IT'S BEEN A BUSY YEAR AT THE MEYERS HOUSE AND THE ALAMEDA MUSEUM

THE HISTORIC CARRIAGE HOUSE NEARED COLLAPSE

THE “MOTHER SHIP” – THE ALAMEDA MUSEUM – RECEIVED IMPORTANT IMPROVEMENTS AS WELL

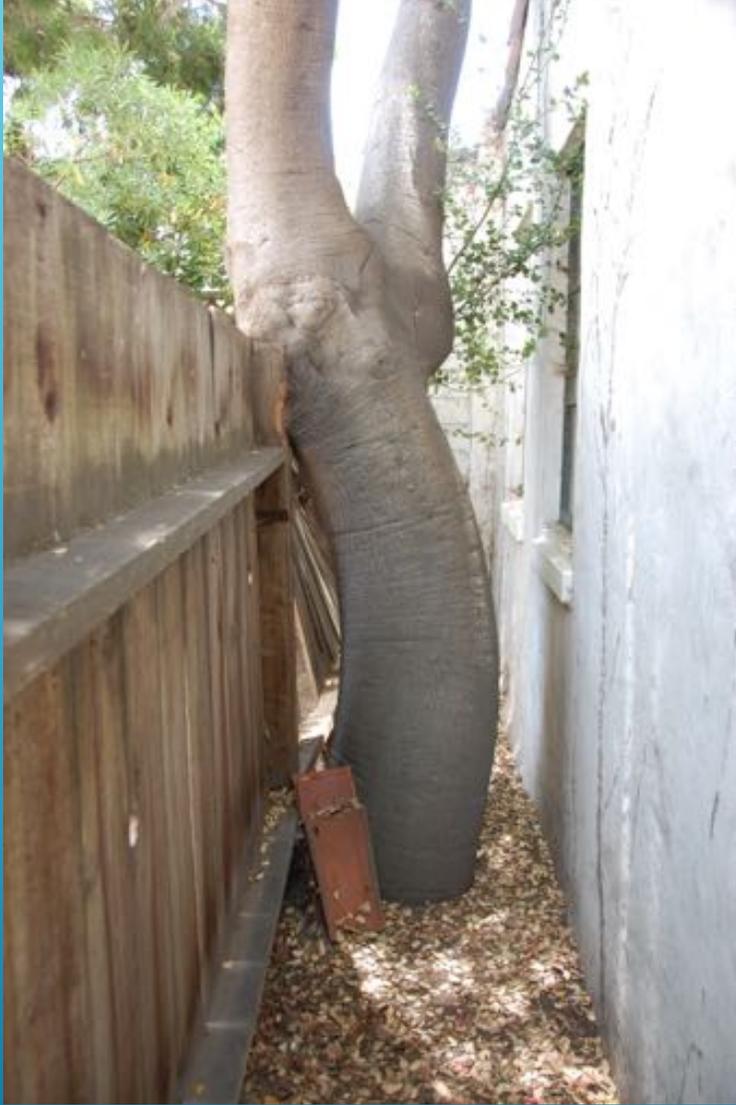
THE 30 YEAR-OLD PERIMETER FENCE AT MHG WAS COLLAPSING

Between the studio and the fence, an oak tree threatened both. The fence fell, and some foundation cracks appeared, a portent of more serious damage if the tree were left.

UNWELCOME INTRUDER

The Museum applied for a removal permit, required because oaks are protected in Alameda. The City approved the request, and the tree was removed.

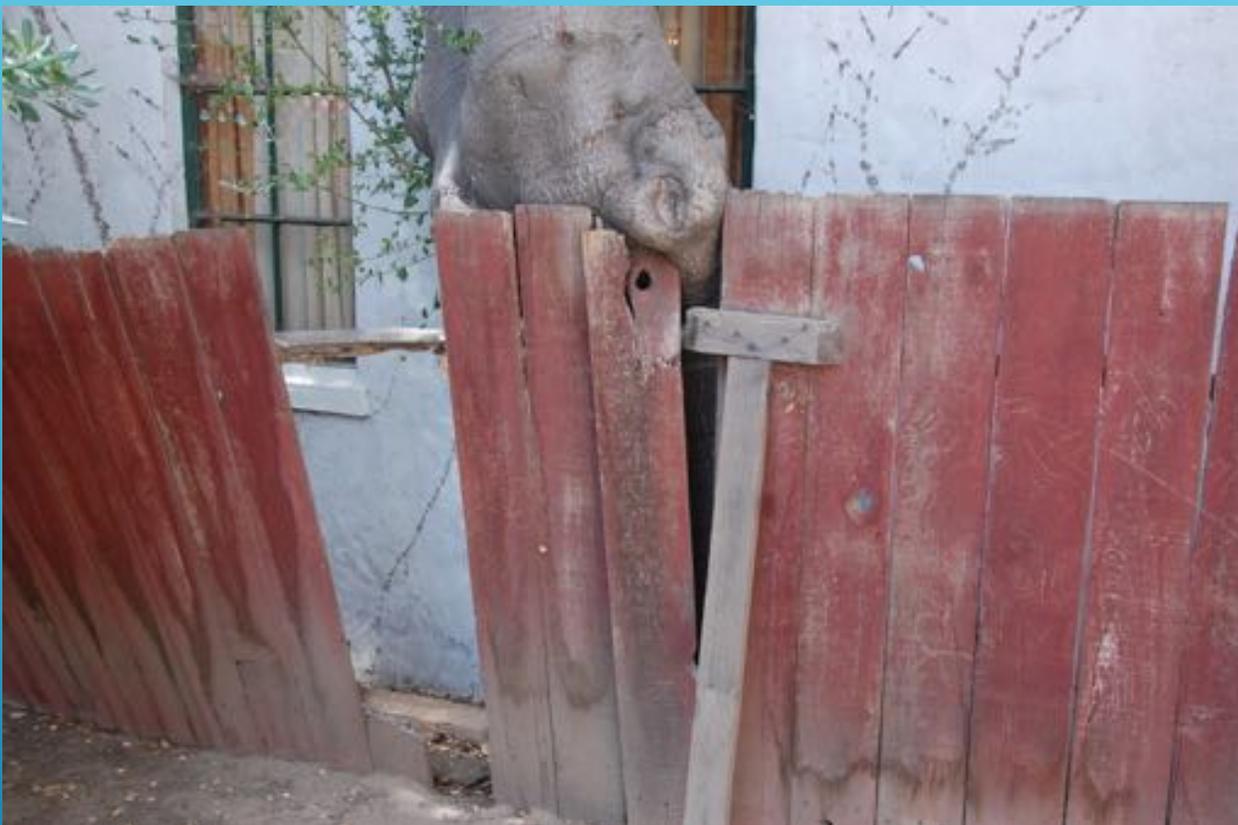
THE TREE WAS WINNING

The rickety fence was no match for the vigorous oak tree

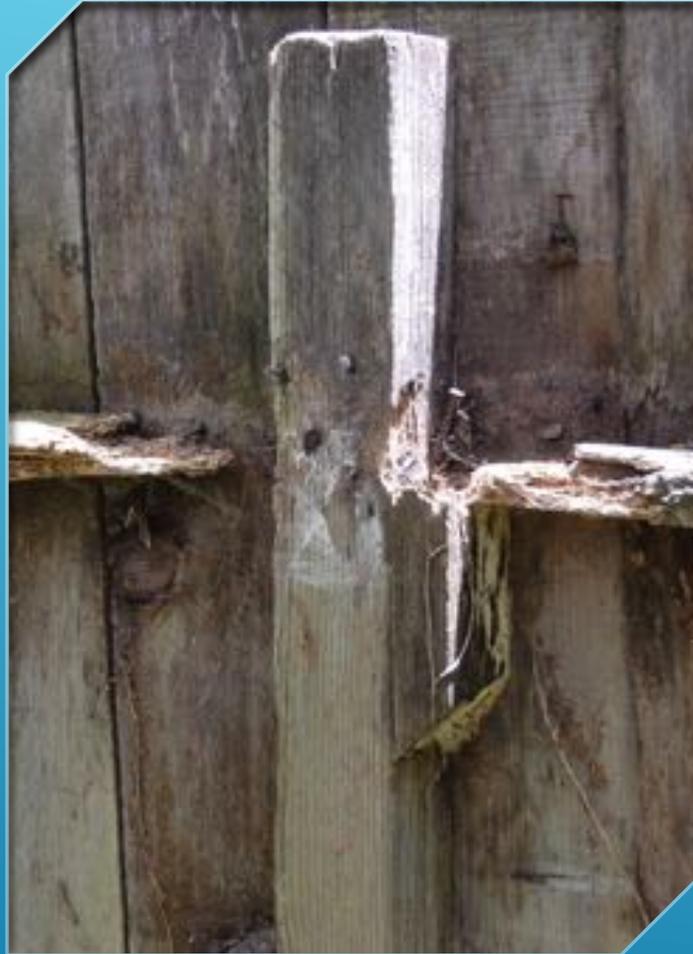
THE OAK TREE WASN'T THE ONLY PROBLEM WITH THE FENCES

Thirty years of weathering had taken a toll. None of the fences on either side of the rear parking area were salvageable.

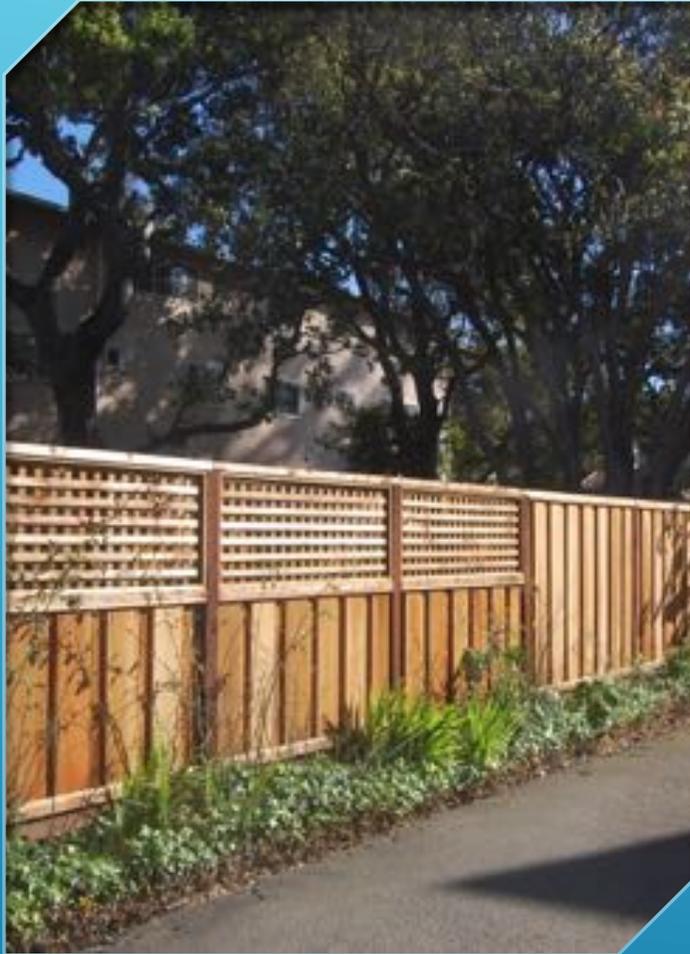
THE NEW FENCE

The new fence provides improved security and an attractive appearance on the Central Avenue side.

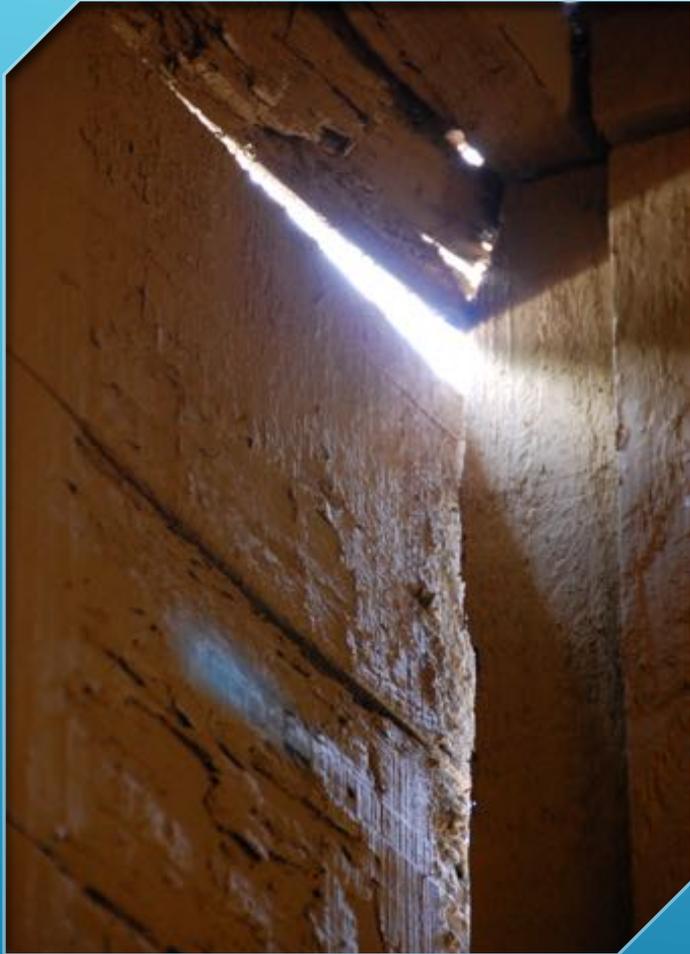
SUNLIGHT STREAMED THROUGH GAPS IN THE EXTERIOR WALLS

Built without a real foundation, 110 years of weathering, dry rot and termites brought the building to the point of collapse.

Here, light shows through a back corner of the building. The original corner support post had rotted away and fallen.

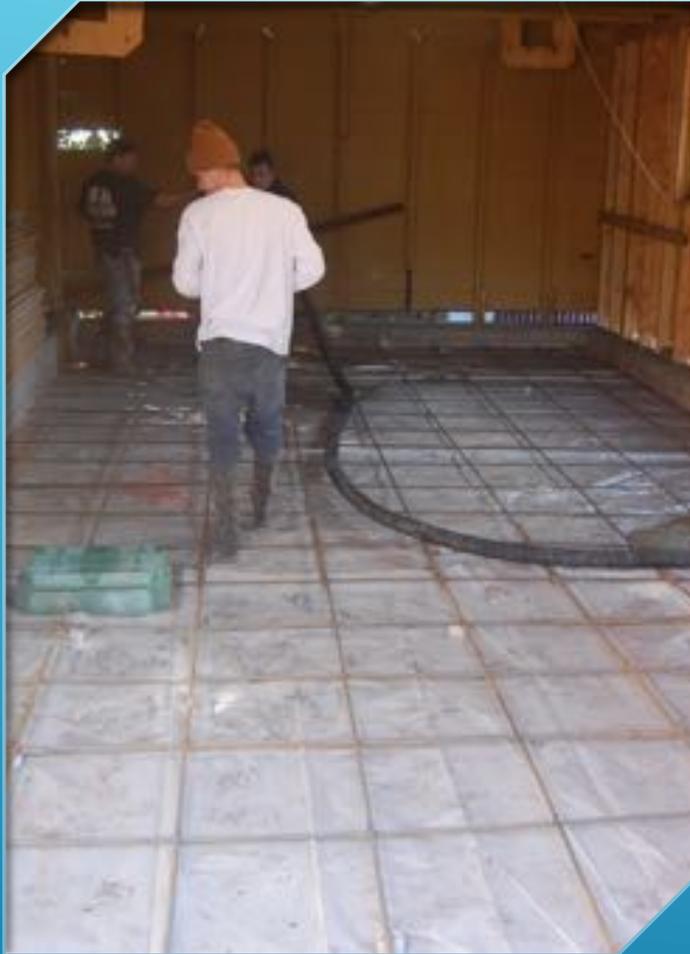
NEW FOUNDATION AND SLAB NOW PROVIDES A SOLID FOOTING

Jameson Construction stabilized with temporary bracing and a new foundation and slab were constructed. Note the reinforcing steel.

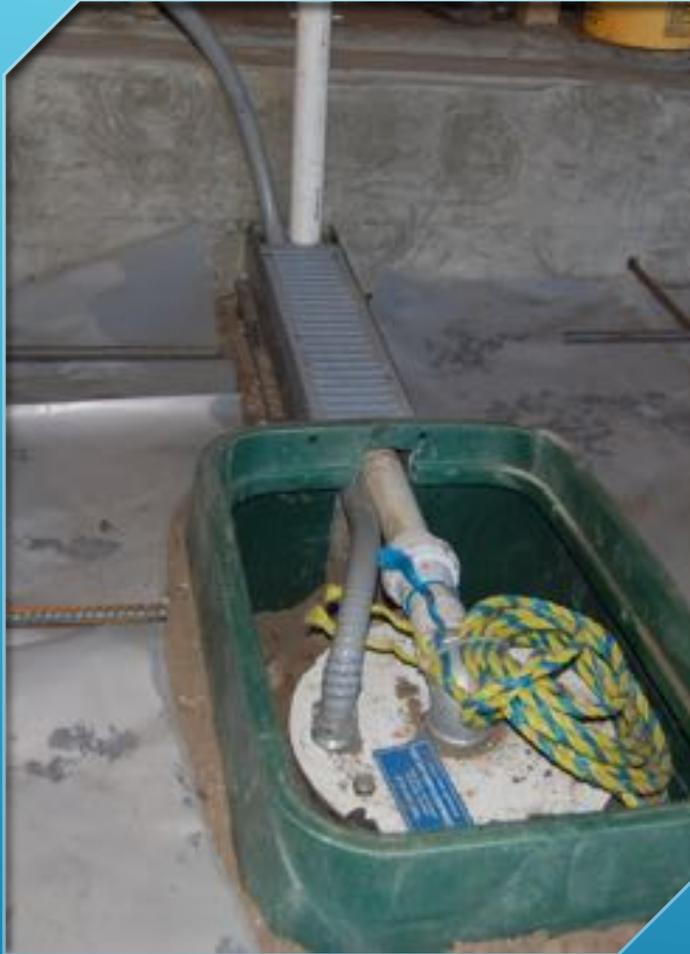
THE FLOOR WAS LEVELED

The well which provides irrigation water for the Meyers House gardens, was reworked to make it level with the new slab. The huge iron tank that had once stored water was cut apart by local Boy Scouts and recycled.

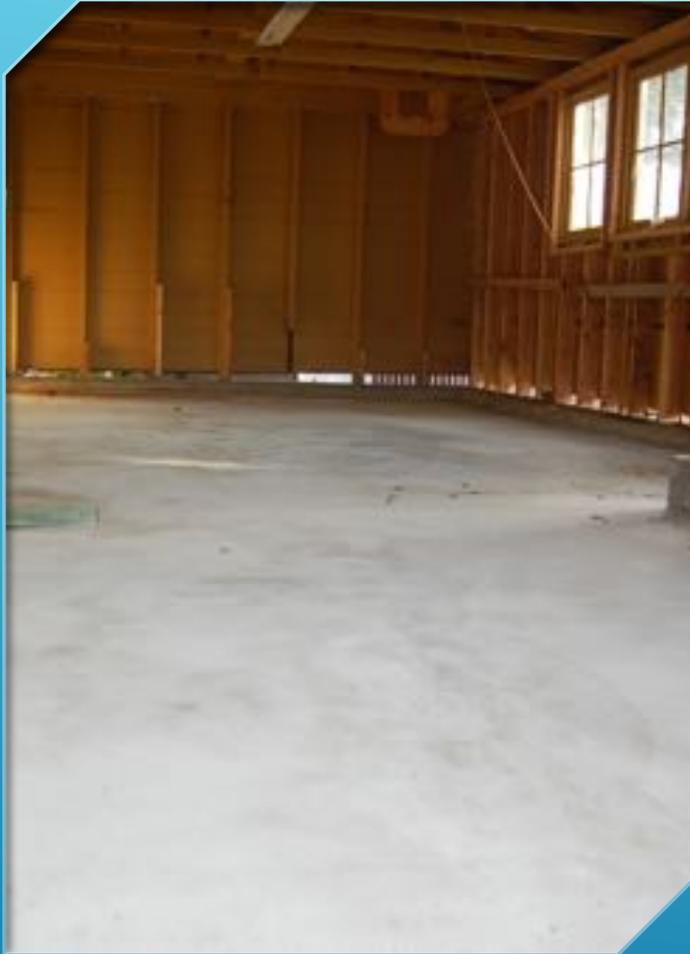
THE NEW FOUNDATION WAS NECESSARY, BUT NOT SUFFICIENT...

The walls were still fragile, and more construction was required to stabilize the structure, add modern electrical service and dress up the inside.

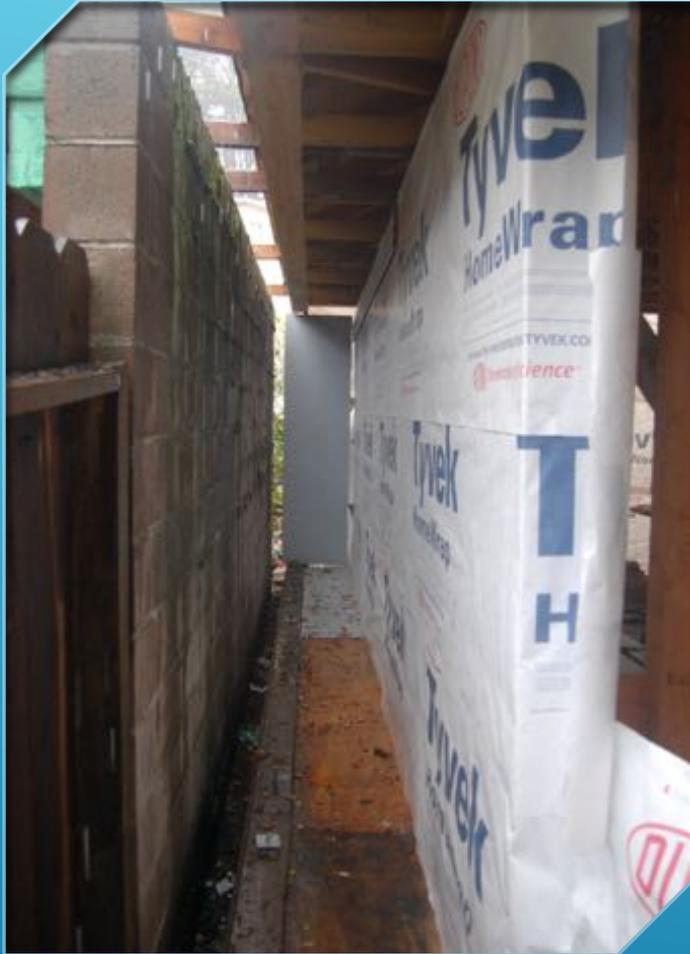
THE WEST AND NORTH WALLS WERE COMPLETELY REBUILT

The west wall is inches away from a neighboring building. A new wall using original siding was built two feet away from the foundation and slid over when completed - slick engineering. A waterproof membrane provides additional protection.

The north (back) wall was rebuilt with new material.

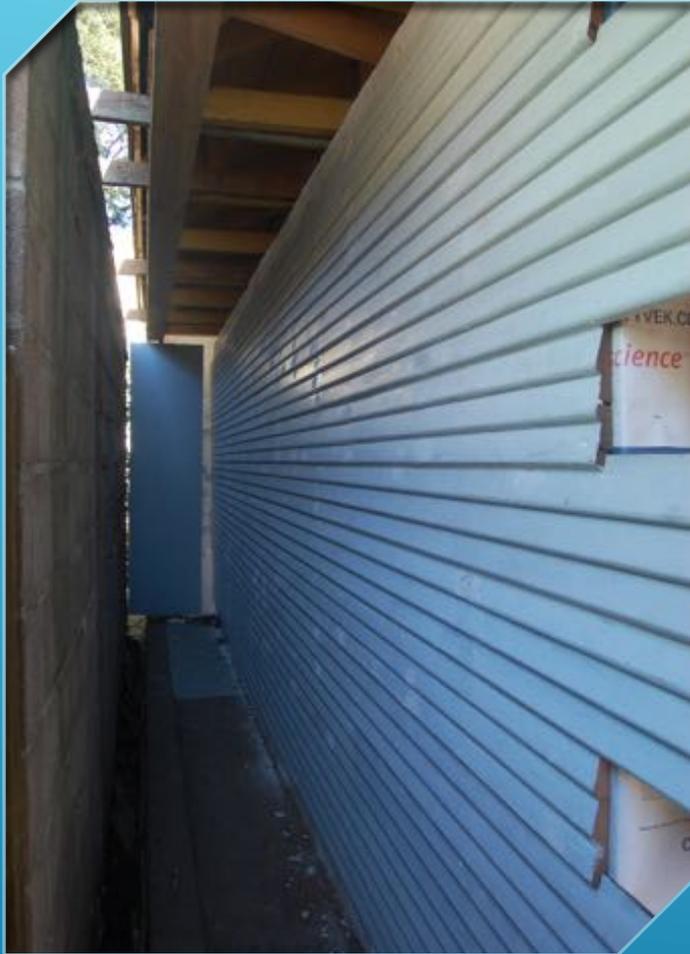
ORIGINAL REDWOOD SIDING WAS RECYCLED WHEN USABLE

The west wall siding was primed, repaired and attached to the new support structure with stainless steel ring nails. This original siding received two coats of high quality exterior paint and the entire wall was repositioned onto the new foundation.

Every effort was made to help the wall last for years.

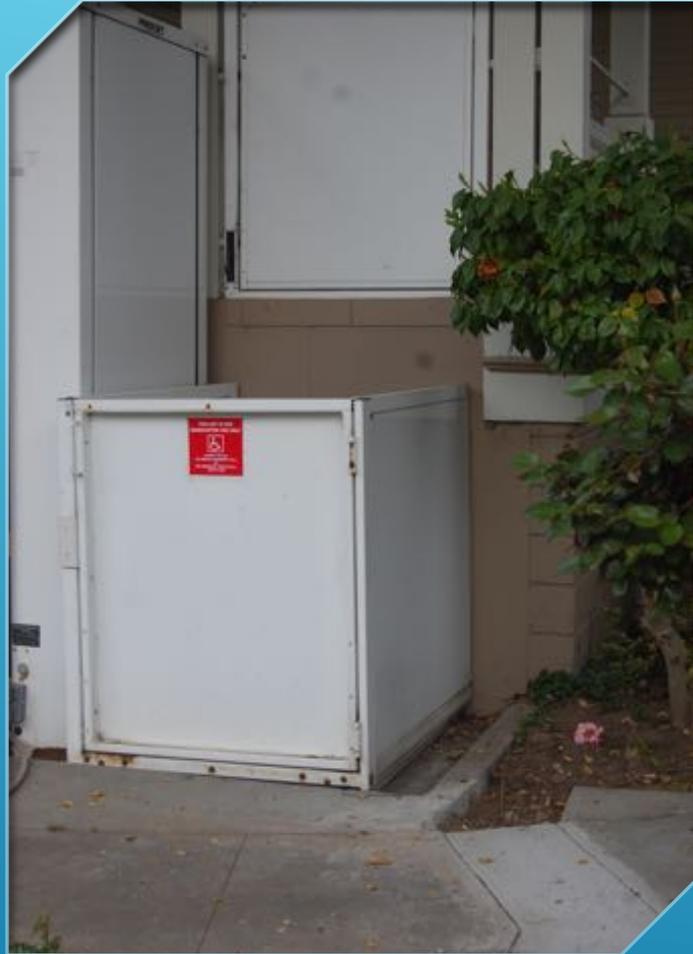
THE WHEELCHAIR LIFT IS BROUGHT BACK TO LIFE

Unmaintained for several years, the lift was repaired due to water damage to its vital parts. The drainage system was changed to keep the vital operating parts protected in wet weather. The lift is now checked regularly.

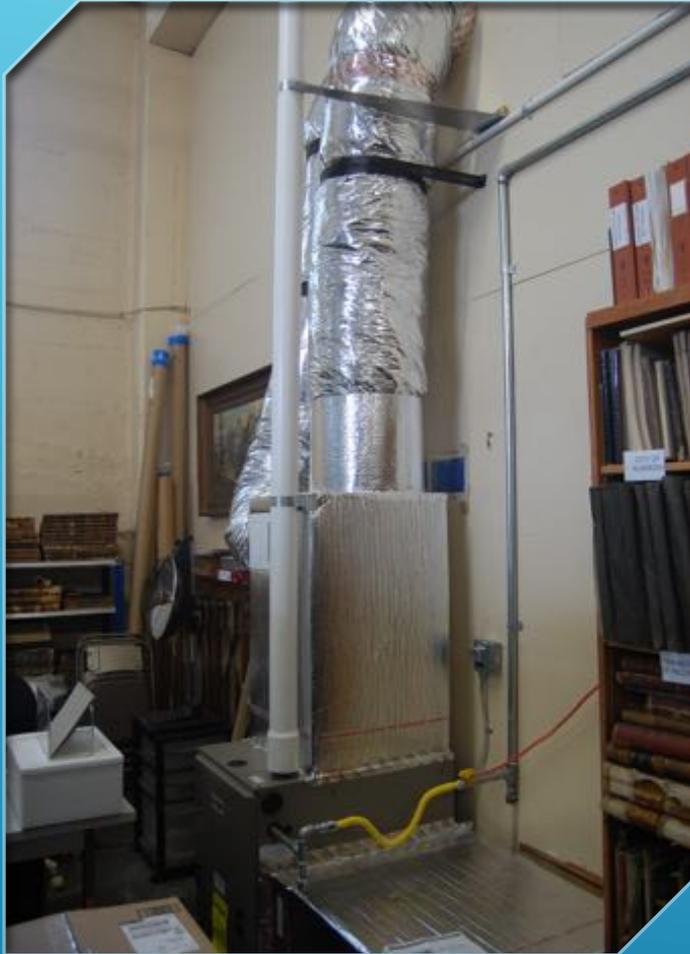
TUCKED INTO A CORNER OF THE WAREHOUSE, IT HEATS THIS AREA TOO.
